# Building Inspection Report

## 123 Easy Street

**Inspection Date:**  
01.01.10

**Report Number:**  
2010-SAMPLE

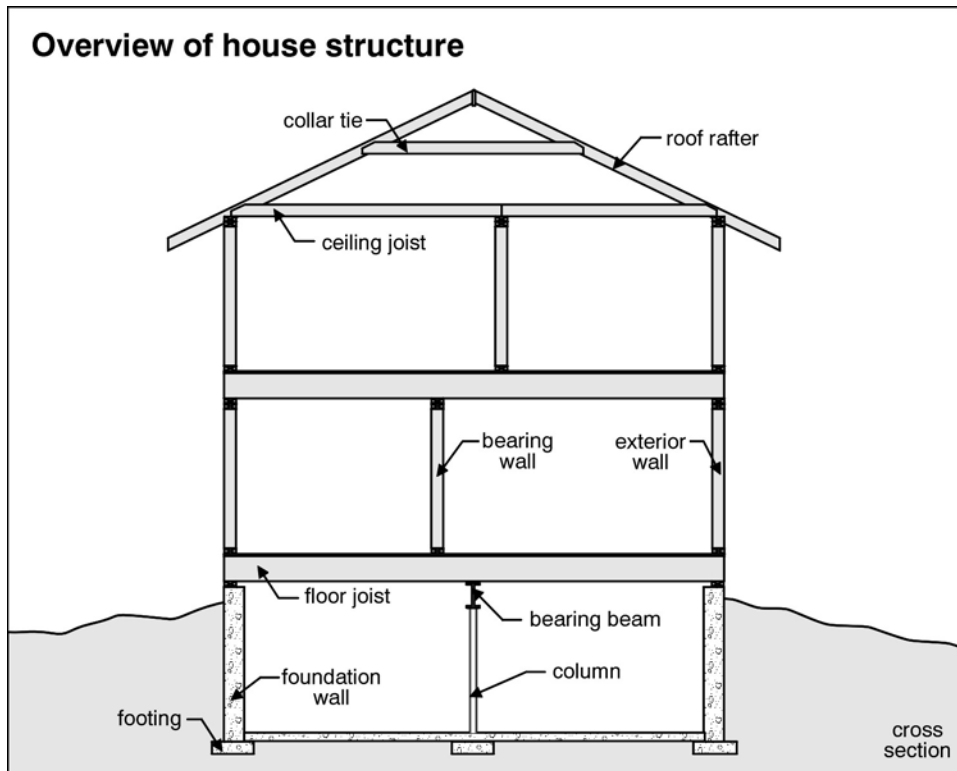
- **Monitor:** Evidence of a possible addition/alteration was noted at the master bedroom/office wall. It is recommended that a copy of any signed off final building permits be obtained from the current owner for work performed on the structure.

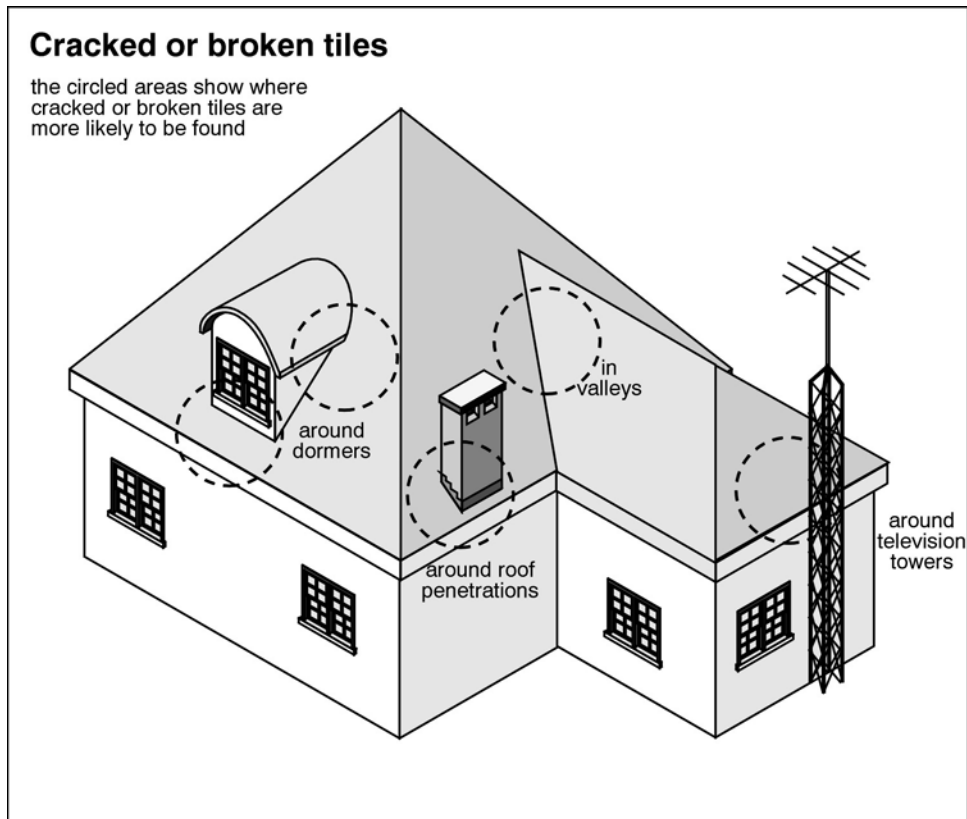
- **Repair, Monitor:** The roofing was found to be in need of repair (evidence of prior leaking at valley flashings and rake edge tiles). It is recommended a licensed roofing contractor be contacted to fully investigate conditions noted at the roof.

- **Improve:** It is recommended that trees near the structure be trimmed back to avoid possible physical damage to the roof.

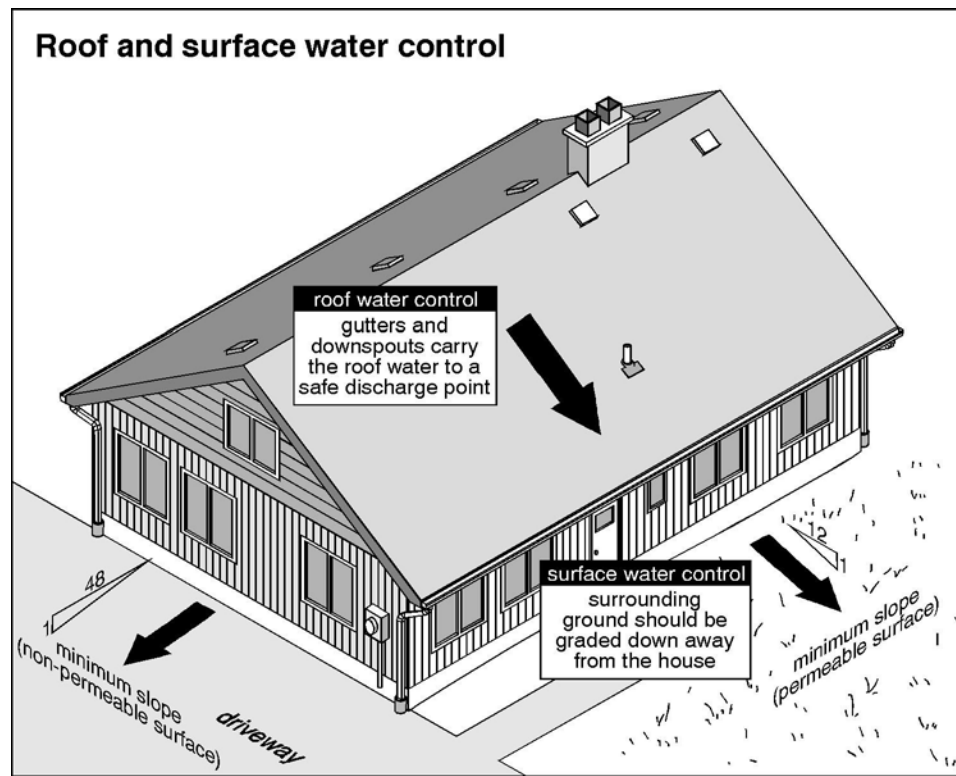
- **Monitor, Improve:** Larger stucco cracks and/or patching were noted at several locations around the perimeter of the structure.

- **Monitor, Improve:** Medium sized cracks were noted at the concrete driveway.

- **Improve, Monitor:** Larger crack(s), and lifting/heaving was noted at the concrete walkway(s).

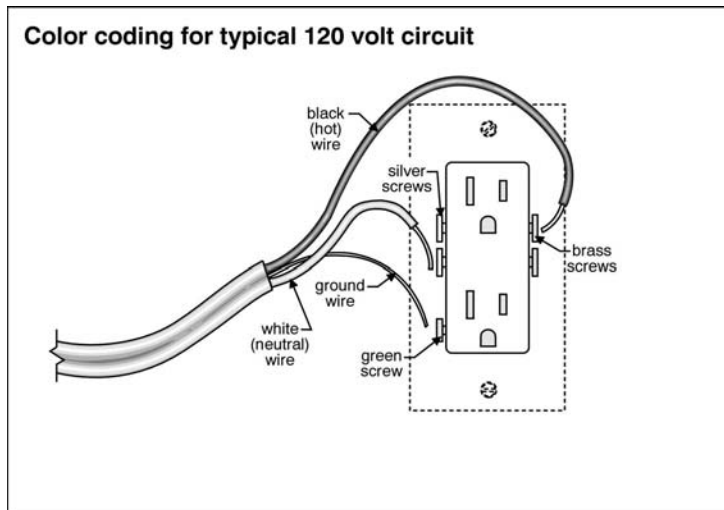
- **Repair:** Exposed wiring without conduit was noted at the garage (right front corner, right wall, and right front corner).

- **Repair:** Missing blanking plate(s) were noted at the garage electrical sub-panel.

- **Repair, Safety Issue:** Non-ground fault circuit interrupter (GFCI) protected outlet(s) were noted at the garage right wall.

- **Repair:** Missing light fixture globe(s) were noted at the right side exterior.

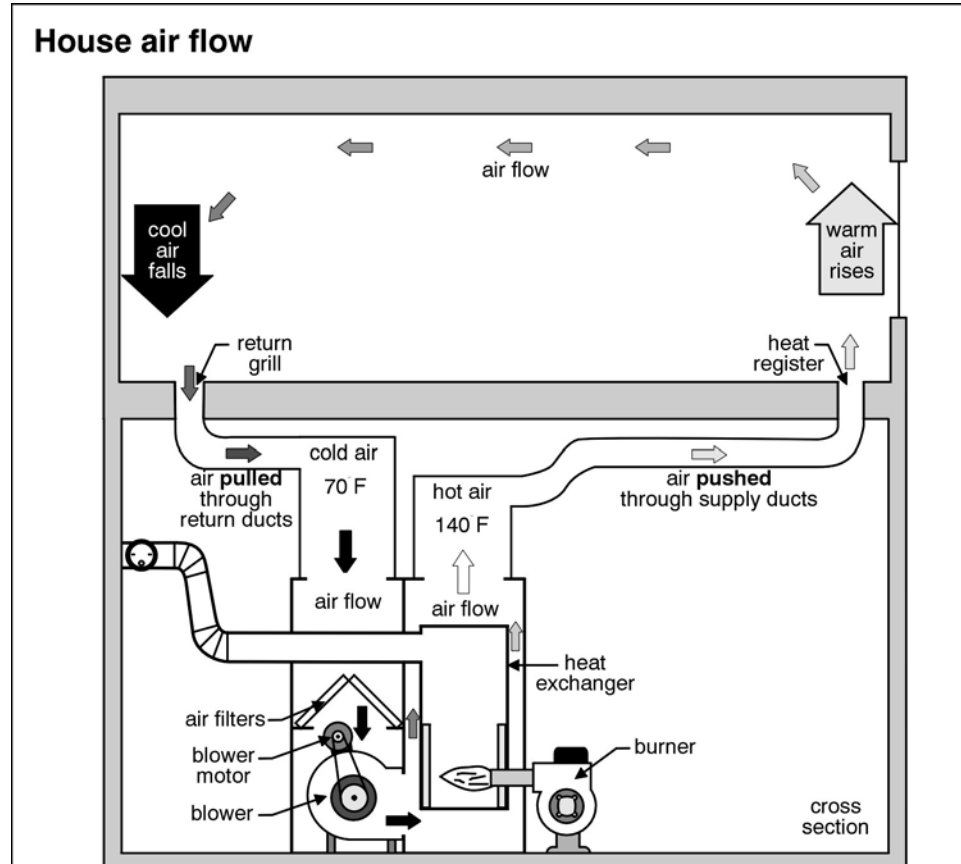
- **Repair:** Damaged fiberglass insulation was noted at the heater return duct (in garage next to heater).

- **Repair, Safety Issue:** Oxidation/corrosion was noted at the heater vent flue (in garage). It is recommended that a licensed HVAC contractor be contacted for further inspection/repair.

- **Improve:** The air filter(s) were noted to be dirty and in need of replacement at the time of the inspection.

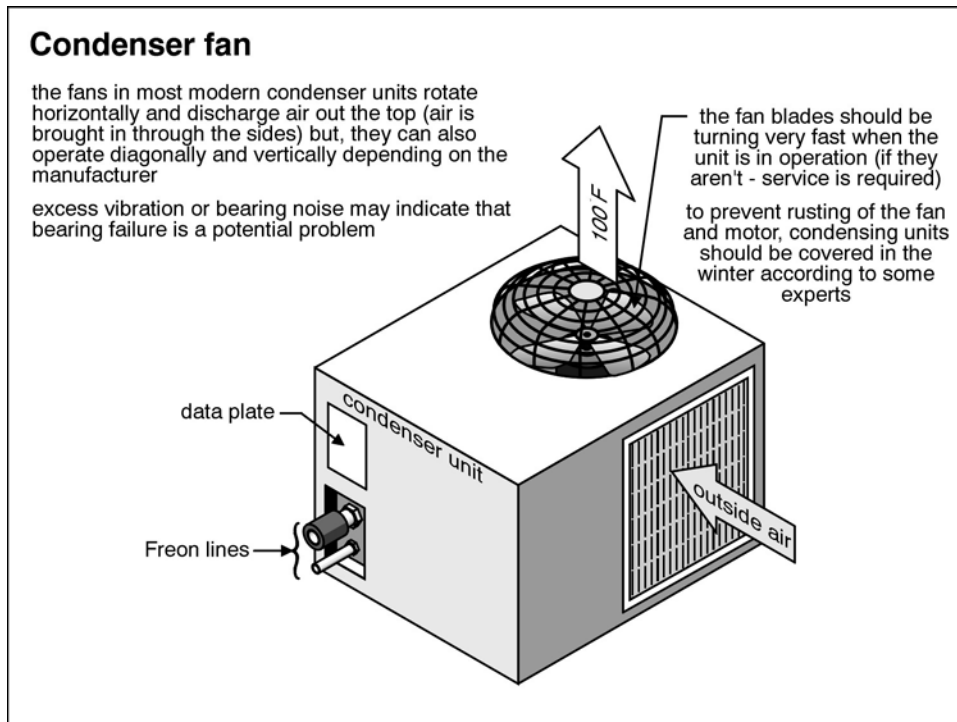
- **Monitor:** Deteriorated fins were noted at the air conditioner condenser/compressor unit.
